60 VINING COURT CONDOMINIUM

MILESTONE INSPECTION REPORT

PROJECT NO. 23-1326

Subject: **25 Year - Phase 1 Milestone Structural Inspection Report
60 Vining Court Condominium, Ormond Beach**

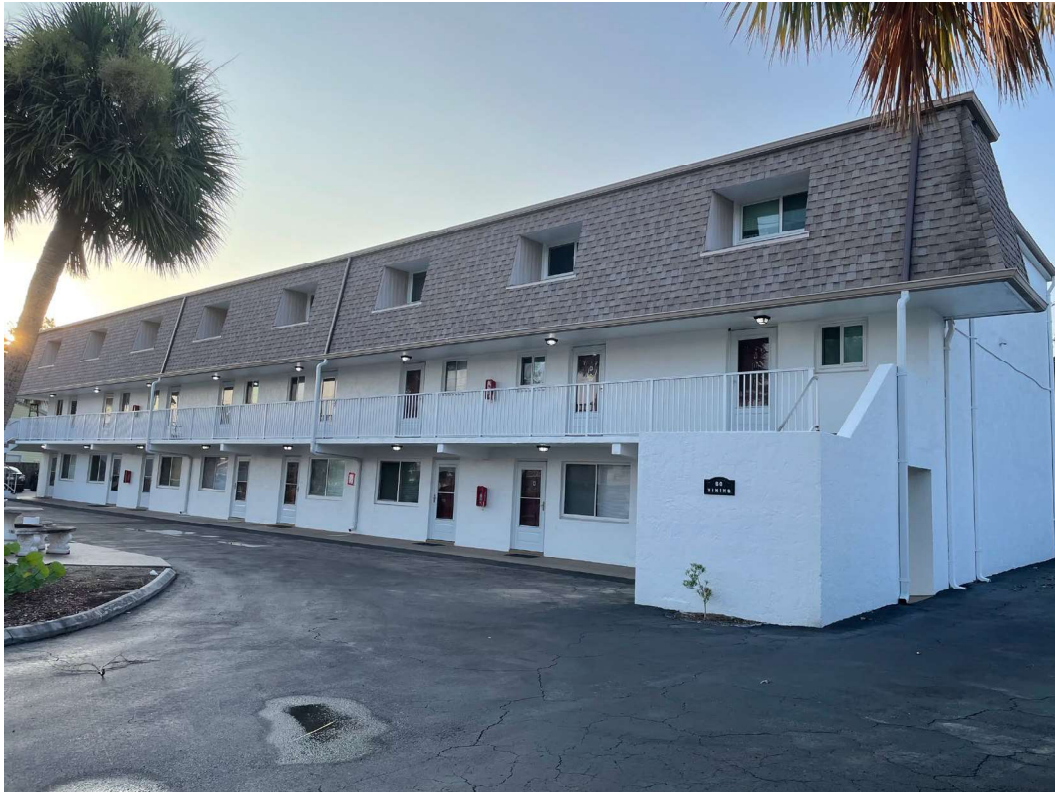
Photograph #1: Front elevation of building

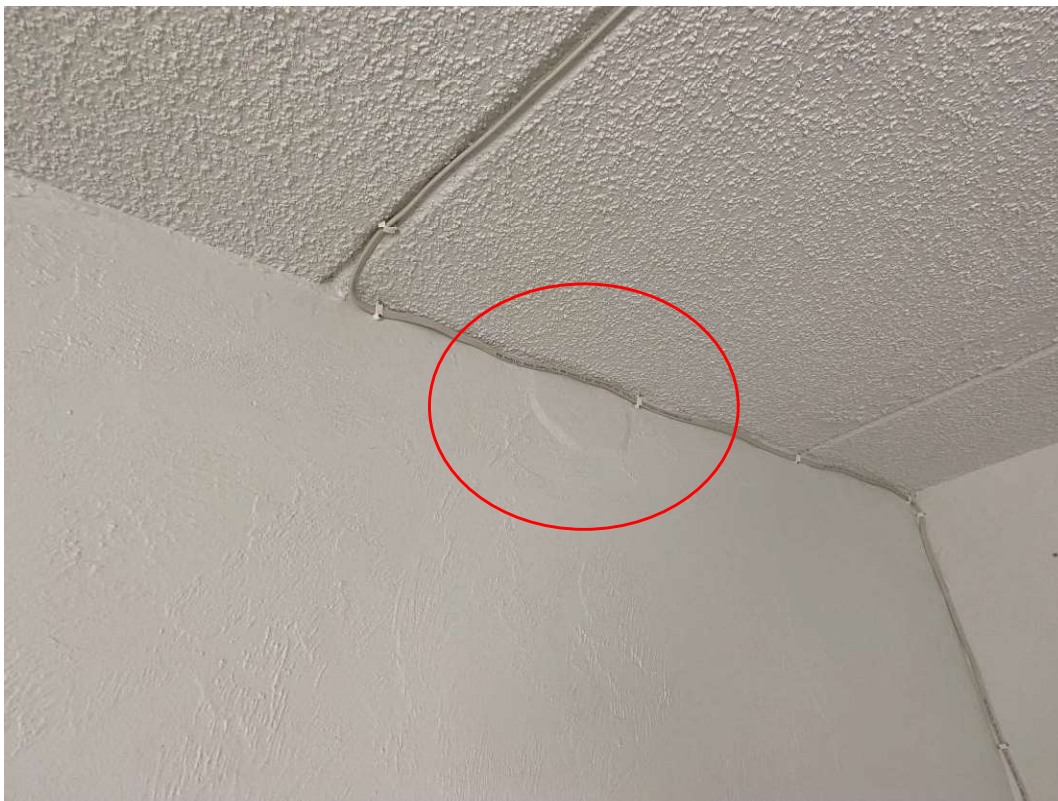
The building structure is in great condition with no substantial structural deterioration. The limited amount of concrete damage detected appears to be from the corrosion of embedded reinforcing steel. Two concrete spalls were identified on the walls in Unit 4. One was on the top of the West bedroom wall and the other was on the top of the West living room wall. See Appendix A, photographs #2 and #3, of the damage. Both areas of damage were small in size and are not considered substantial structural deterioration.

Photograph #2: Bedroom concrete spall in Unit 4

The building is in excellent structural condition. Two small concrete spalls (damage) were detected in Unit 4; however, they are not considered substantial structural deterioration at this time. Preventative repairs are recommended to address the damaged areas noted.

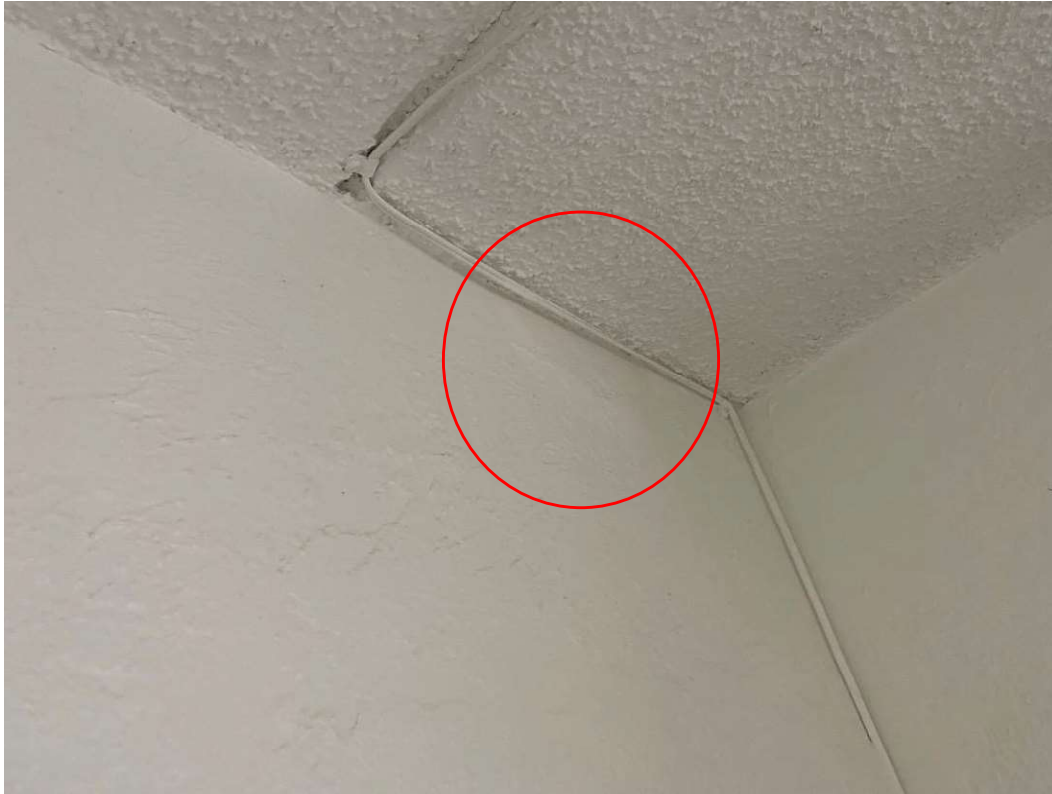
Photograph #3: Living room concrete spall in Unit 4
