RESERVE STUDY REPORT DRAFT

Hammocks at Palm Harbor
200 Cedar Cove
Palm Coast, FL 32137

January 1, 2024

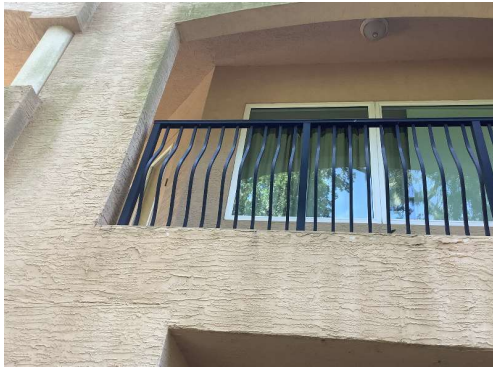
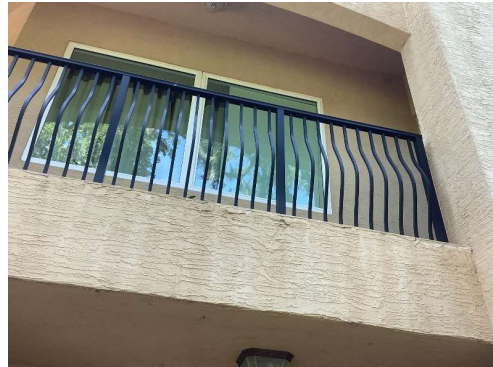
Balcony Railing Repaint and Repair - 2025

This category refers to costs associated with the repair/ stain/painting of balcony railings. Barring unforeseen damage to the subject's railings, and assuming proper and routine maintenance, a minimum useful life of approximately 10 years can be expected. The current replacement cost estimate is based on industry standards, national cost estimating indexes, the number and placement of the association's balcony railings, and our experience with this type of component. Repair and paint/ stain have historically lengthened the life of railing assemblies.

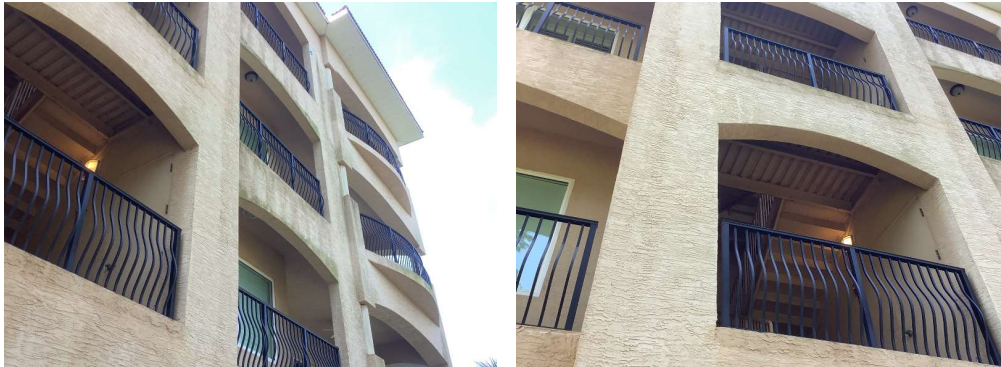
Balcony Railing Replacement continued...

This category refers to costs associated with the replacement of balcony railings. Barring unforeseen damage to the subject's decking, and assuming proper and routine maintenance, a minimum useful life of approximately 40-50 years can be expected. The current replacement cost estimate is based on industry standards, national cost estimating indexes, the number and placement of the association's balcony railings, and our experience with this type of component. Recoating of balconies has historically lengthened the life of railing assemblies.

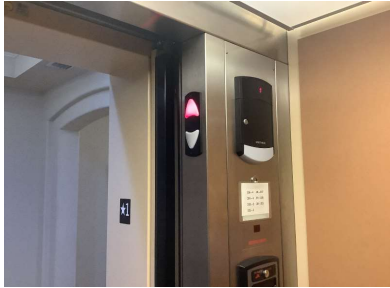
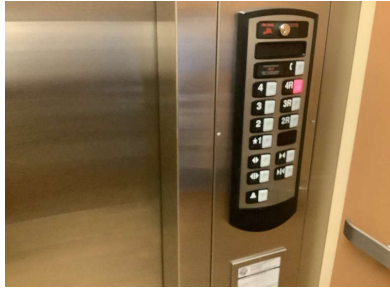
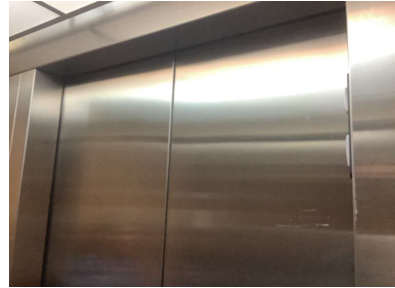
Elevator Modernization - 2031

Full modernization of elevator cabs, walls, flooring, and buttons, including (but not necessarily limited to), controllers, door hardware, etc. has been observed on life cycles in the 20-25-year range in properties of similar quality, assuming a typical maintenance program. The useful life is often determined by an association's dissatisfaction with the elevator's appearance and functional interior components. The current cost estimate is based on construction cost indexes and is in keeping with actual costs incurred for similar modernization projects.

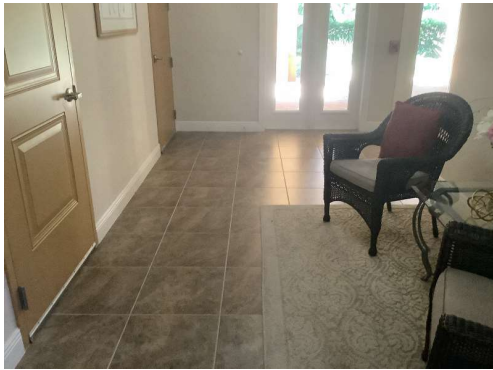
Common Area Allowance - 2033

This allowance was included for as-needed furniture/furnishings replacement and/or renovations within the common area lobbies, meeting room, and restroom, including (but not necessarily limited to) furniture, decorative lighting/lamps, window treatments, area rugs, mirrors, wall art, plants, electrical/plumbing fixtures, wall/ceiling finishes, flooring, etc. The lump sum cost estimate is based on the quality of the existing inventories, and our experience with similar properties. As with any cosmetic renovation, the actual costs and time frames may vary from our estimates, based on association preferences.

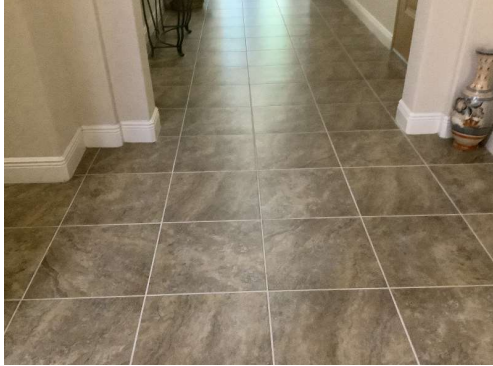
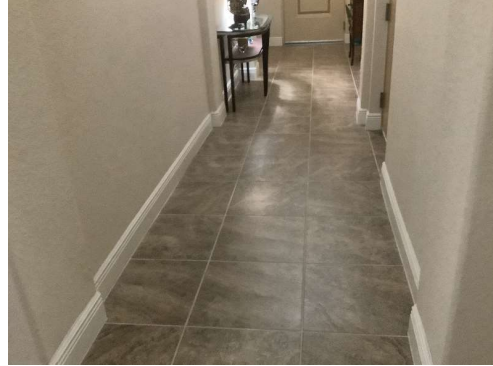
Common Area Tile Flooring continued...

This entry was included as needed for the hallway/ landing tile floors in the common area replacement. The lump sum cost estimate is based on the quality of the existing inventories, and our experience with similar properties. As with any cosmetic renovation, the actual costs and time frames may vary from our estimates, based on association preferences.

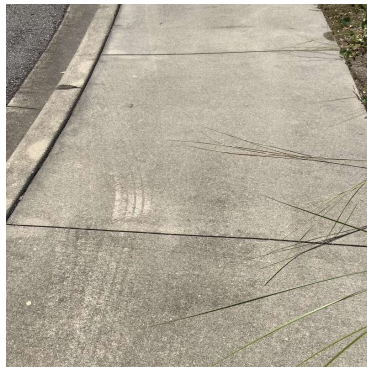
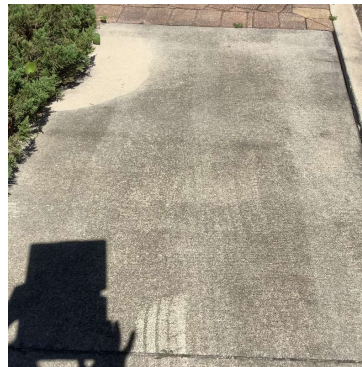
Grounds Concrete Allowance - 2041

Replacement of the concrete paving (curbing, sidewalks, etc.), decorative concrete features, seawall, and walkways should not be necessary at any one given time under normal operating conditions. As such, reserving for total replacement is not considered practical or necessary. The amount of this allowance and the useful life cycle may vary widely from actual expenses

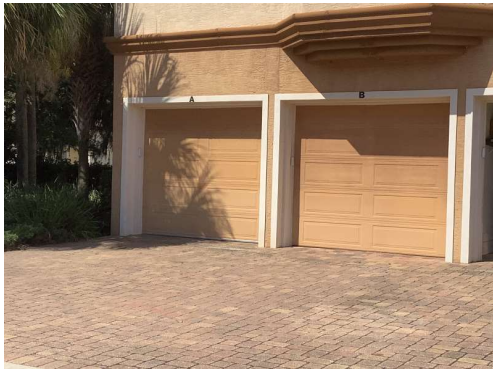
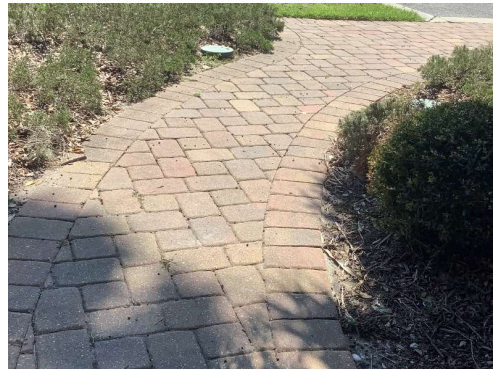
Building Area Pavers Reseal - 2025

This category refers to costs associated with the replacement and repair/ resealing of pavers in areas. Barring unforeseen damage, and assuming proper and routine maintenance, a minimum useful life of approximately 5 years can be expected.

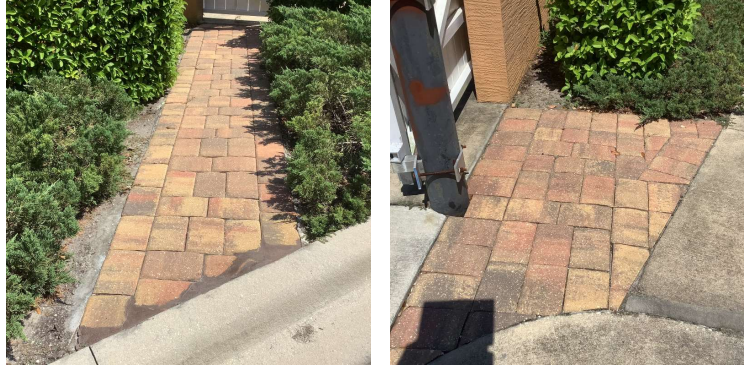
Garage Area Pavers Replacement continued...

This category refers to costs associated with the replacement and repair/ resealing of entrance and walkway pavers areas. Barring unforeseen damage, and assuming proper and routine maintenance, a minimum useful life of approximately 35 years can be expected. The current replacement cost estimate is based on industry standards, national cost estimating indexes, and our experience with this type of component

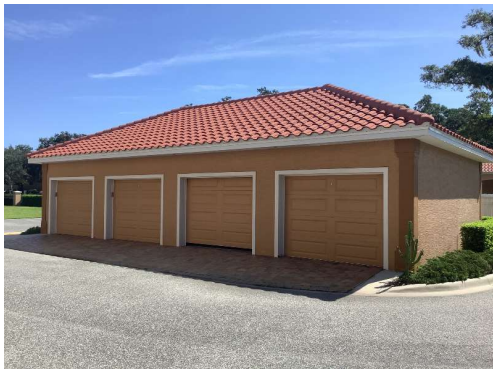
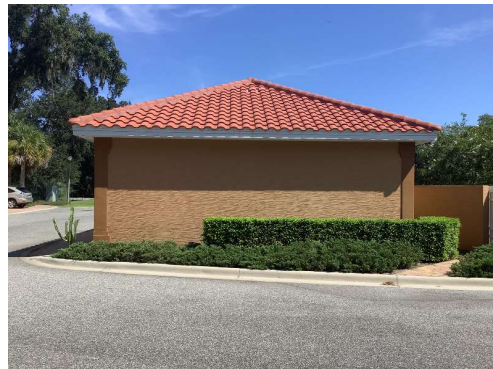
Garage Concrete Tile Roofing - 2045

Data gathered from within the local market suggests a probable life cycle in the 18-20-year range for a professionally designed, installed and maintained roof including gutters. The current cost estimate includes removal and disposal of the existing roofing, typical minor

repairs to the underlying roof structures, flashing, etc., and installation of like roofing.

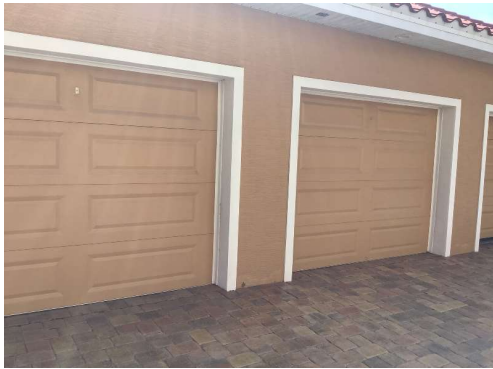
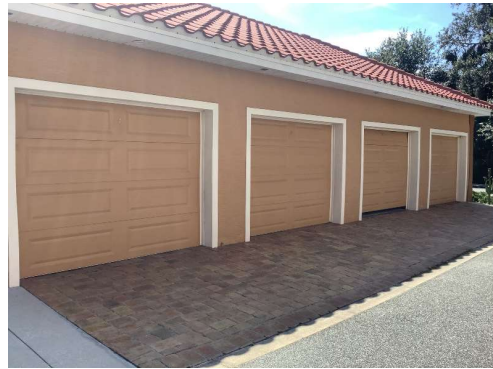
Garage Doors - 2040

This category refers to unit garage door replacement including facings and installation. The current replacement cost estimate is based on industry standards, national cost estimating indexes, and our experience with this type of component. Doors, which are replaced on a historical 25-year schedule, are subject to conditions such as construction, quality, material, and elements.

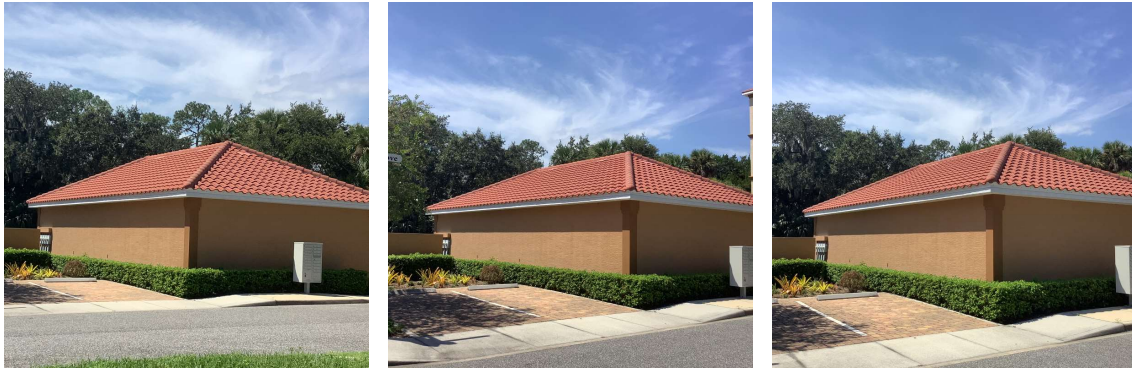
Garage Exterior Paint continued...

To ensure proper protection of the underlying concrete, stucco, wood, and metal surfaces, the market reflects a maximum 7-year useful life for exterior painting & waterproofing (instead of an association-purchased 10-year warranty). The current average per dwelling cost in keeping with market standards for similar buildings includes typical minor concrete/stucco repairs, surface preparation, as-needed window/sliding glass door caulking, and painting/refinishing of all exterior concrete, stucco, wood, and metal surfaces (including railings and window/slider frames). This does not include windows and doors (see separate entry where applicable).

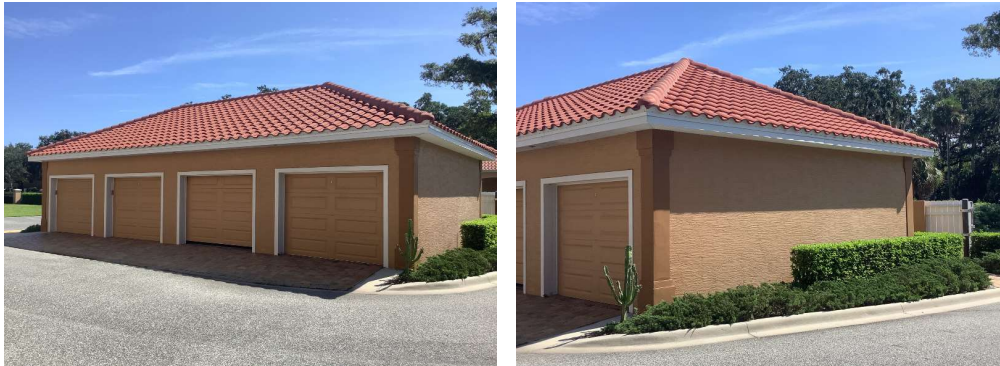
Garage Restoration Allowance - 2035

This component is expected to have a useful life cycle of 10 years based on location, products

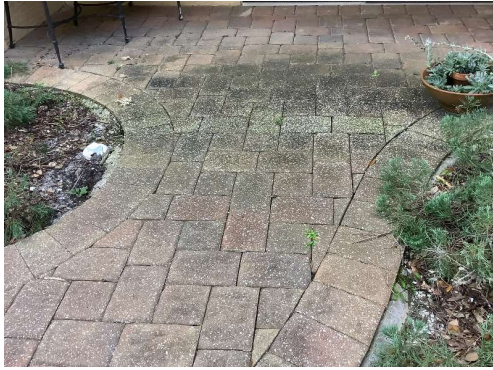
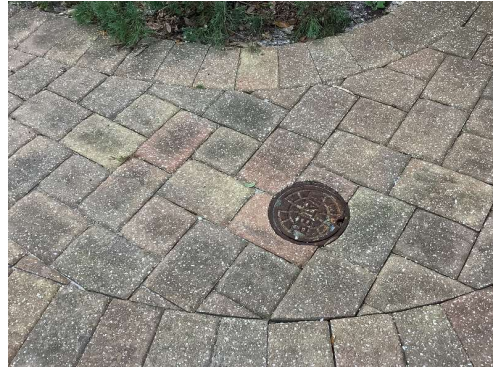
Building Area Pavers Replacement - 2046

This category refers to costs associated with the replacement and repair/ resealing of entrance and walkway pavers areas. Barring unforeseen damage, and assuming proper and routine maintenance, a minimum useful life of approximately 35 years can be expected. The current replacement cost estimate is based on industry standards, national cost estimating indexes, and our experience with this type of component

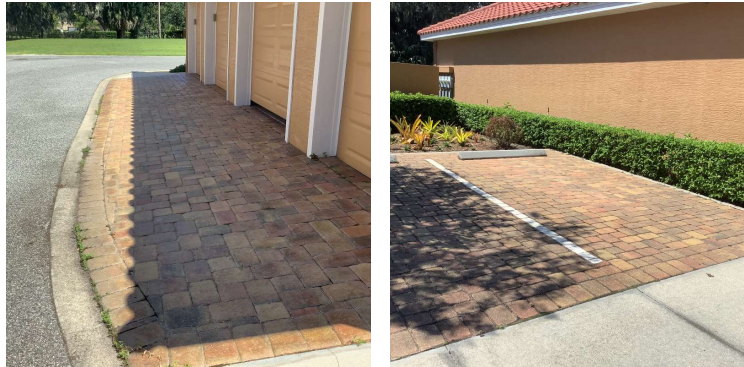
Garage Area Pavers Reseal continued...

This category refers to costs associated with the replacement and repair/ resealing of pavers in areas. Barring unforeseen damage, and assuming proper and routine maintenance, a minimum useful life of approximately 3 years can be expected.

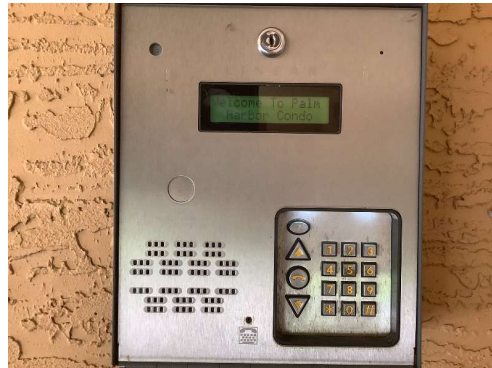
Keypads - 2031

Data gathered from within the local market area indicates that while minor component repairs/replacements (key fob readers, keypad, hardware/software, etc.) can be expected as a function of ongoing maintenance, total system modernization and/or replacement can be expected on a life cycle in the 15?20-year range.
